A Guide Book for the Inspection,  
Classification and Restoration  
of Damaged or Worn Conductors

# OVERHEAD DISTRIBUTION LINE REPAIR MANUAL

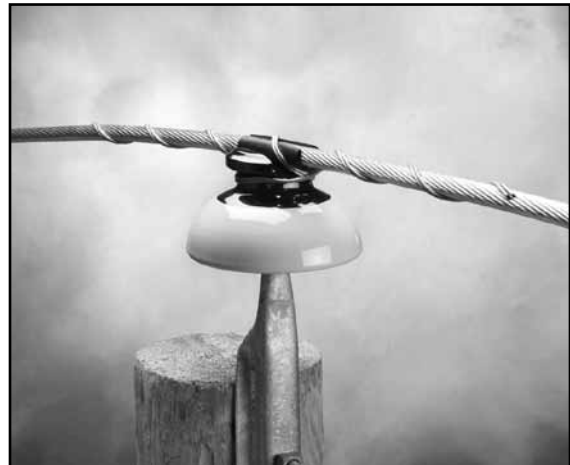
**Figure 3**

Factory-formed tie is less dependent upon lineman skill; result is uniformity of application.

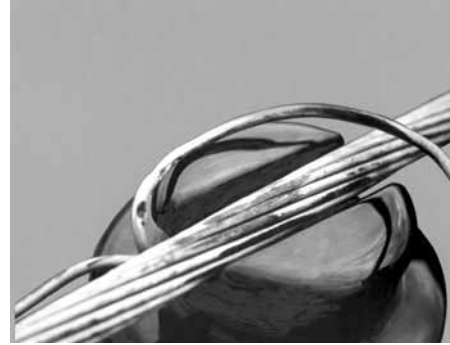
**Figure 4**

Abrasion to outside surfaces is highly visible and therefore easy to detect. (Figure 4) Abrasion damage is a chafing and impact wear that accompanies relative movement between a loose tie and the conductor or armor rods. Even well-made hand ties can loosen if subjected to prolonged or severe motion. Abrasion is surface damage and can be identified by black deposits on the conductor or tie. It can also be identified by aluminum deposit build-up on the insulator and/or scoring of the insulator glaze.

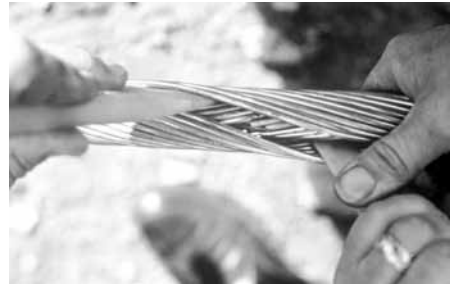
**Figure 5**

Fretting of aluminum wires is a deterioration process created by a rubbing action between two wires (or between a wire and another object). The action wipes away the oxide film normally on the surface of the wires so that the underlying metal is exposed to further oxidation. Since aluminum is a chemically active metal, oxidation occurs at a rapid rate. The back-and-forth motion re-exposes the metal to oxidation and repeatedly makes and breaks the microscopic welds. During this process oxide fragments accumulate and the fretted surfaces become rough. The fragments look like black dust, and the fretted surfaces are usually black. Fretting is often hidden, especially when it takes place on the inner strands of the conductor. On multi-layer conductor, breaks from fretting may sometimes be detected by spreading the outer strands in order to view the inner layers (Figure 5). CAUTION! Do not use screwdriver or other sharp objects that could cause additional damage to the conductor. A nylon-covered tool or nylon fid is best for this purpose.

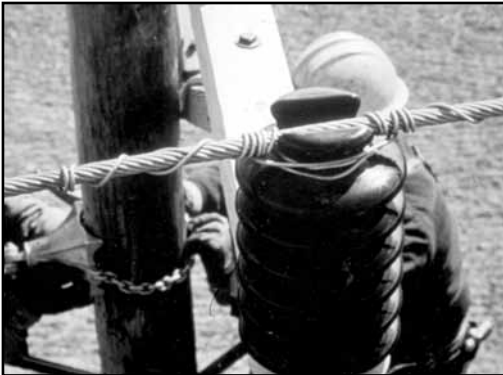
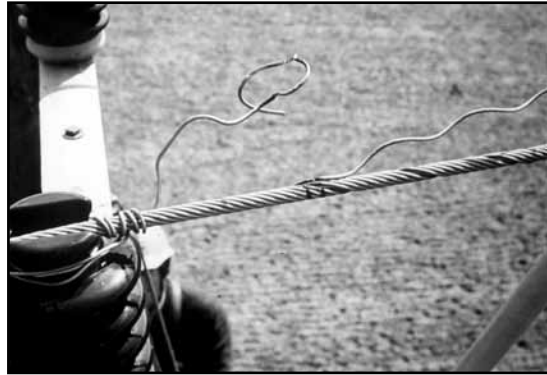
In Figures 9 and 10, note that the hand tie is removed from the right side, revealing moderate abrasion of both tie wire and armor rods. The wear at the end of the tie wire on the right reveals that it became loose in operation, but did not release the conductor (sometimes called a “floater”). Since the wear on the armor rods had progressed to only about 25% of their diameter – a moderate amount – it is not necessary to replace them. Simply remove the old tie, scrap it, and apply a factory-formed tie. Either a PLP Distribution Tie or a WRAPLOCK® Tie may be used. To be sure of correct size and fit, check PLP’s T & D Catalog or contact your PLP representative.

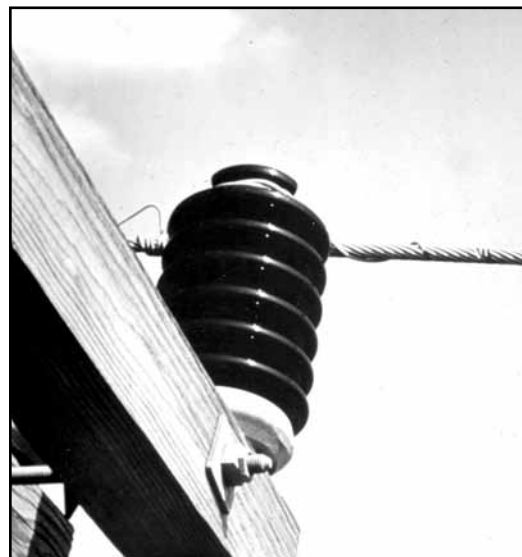
Figure 13 illustrates severe vibration on double-arm construction. However, in this case the damage took place on the field phase to the same extent as on the center phase of single-arm construction. The tie wire has been completely severed and the armor rod wear is less than 50% of the diameter of several rods.

Because the tie wire was severed, it will be necessary to use PLP Spiral Vibration Dampers in conjunction with a PLP Double Support or Double Side Tie depending upon which groove the conductor is applied in.

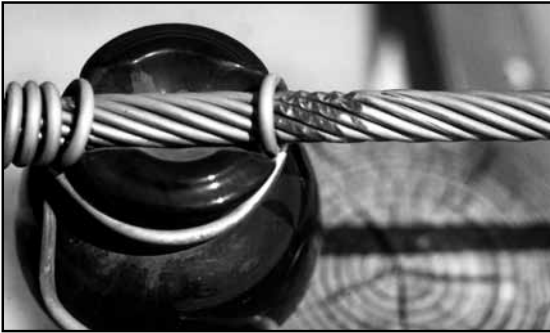
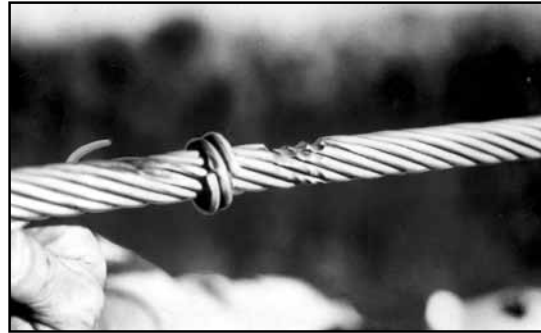
These illustrations reveal broken tie wires at the insulator and armor rods that are more than 50% worn through. (Figures 14 and 15) Excessive dynamic conditions on this line were evidenced by the numbers of buttons that were broken off and floating into midspan; on one span a button was found 525' from its original support assembly and it was lodged against the armor rod of the adjacent support assembly. Radio interference was severe.

Repair procedure is to remove old tie wires and armor rods and carefully check conductor for breaks. If any conductor elements are broken, repair with PLP Armor Rods or a Line Splice and retie with PLP Distribution Tie or WRAPLOCK Tie, then apply Spiral Vibration Dampers. If no conductor strands are broken, use one of the factory-formed ties mentioned above, with dampers.

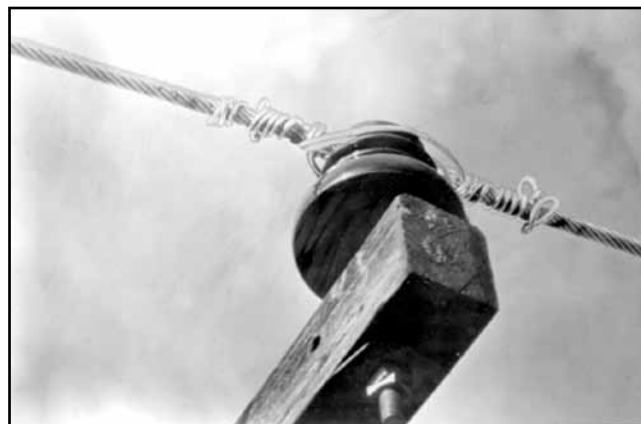
Figure 16 illustrates that hand ties are inadequate for highly active lines. Three weeks prior to the inspection of this line, linemen found the field phase floating free of the insulator at this support point. Note the dark marks of abrasion caused by the old tie wires. After only three weeks the new tie wire (illustrated) was broken. Note the loose loop of the tie. Although motion was severe enough to have broken the tie wire, the three-week period was not of sufficient duration to have caused extensive wear of the armor rods. Removal of the old tie wires and replacement with the PLP Distribution Tie or WRAPLOCK Tie with Spiral Vibration Dampers provides sufficient protection since the armor rods are practically undamaged.

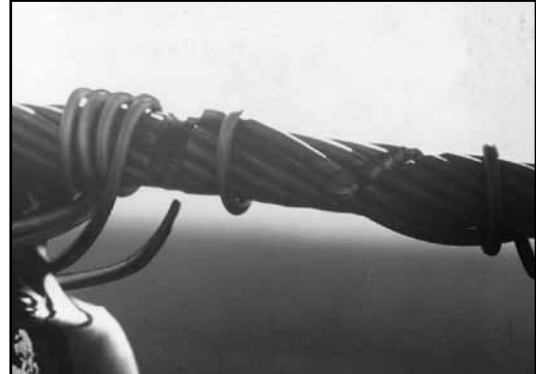
Figures 17 and 18 reveal excessive damage typical of every ridge pin support point throughout this system. Tie wire is broken at several places. Tie wire abrasion has worn the armor rods almost completely through to the conductor. Maximum protection is required here. Procedure is to remove old wires and rods to determine if there is conductor damage. If so, repair with new PLP Armor Rods, Line Splice, or Armor Splice (if steel core damage is suspected, it may be necessary to use a full tension splice) then retie with Distribution Ties or WRAPLOCK Ties and add Spiral Vibration Dampers.

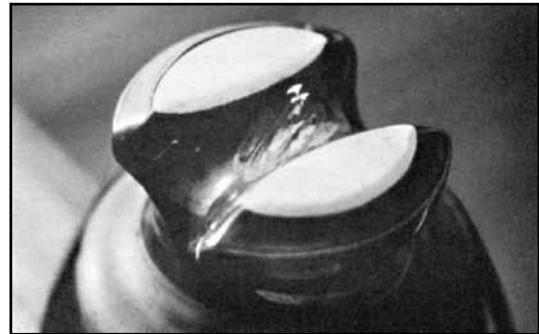
Figure 19

In this case severe vibration has caused abrasion wear to break through the glaze in the saddle of the insulator. (Figure 19) Wear, caused by the hand tie wire can also be seen in the side groove. A WRAPLOCK Tie by itself may prevent porcelain abrasion both in the saddle and the side groove of the insulator. A PLP Distribution Tie will prevent porcelain abrasion in the saddle but in this case, where vibration was severe enough to cause abrasion in the side groove, supplemental use of Spiral Vibration Dampers is recommended.

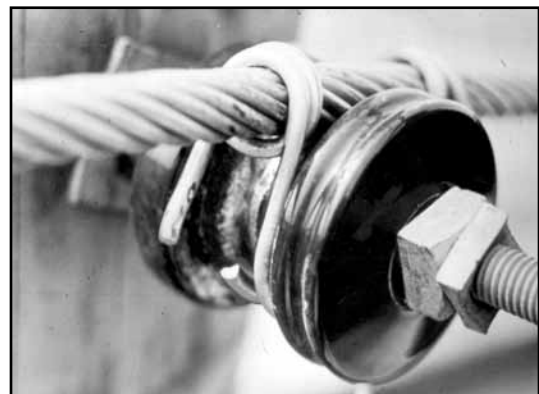
Figure 20

Severed tie wire and mildly abraded armor rods (indicated by black marks) call for removal of tie wires and the application of a PLP Spool Tie and Spiral Vibration Dampers. (Figure 20)

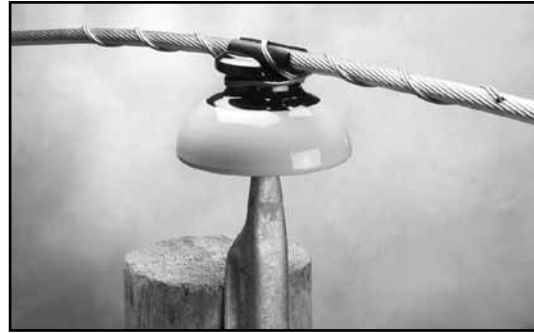
**Figure 29**

The Distribution Tie should repair damage that has occurred to tie wire and/or protective rods at the support point. The Distribution Tie offers protection against future abrasion damage. (Figure 29)

Broken or damaged tie wire should be replaced with the Distribution Tie and the supplemental use of Spiral Vibration Dampers is recommended. (See page 10 for details on Spiral Vibration Dampers.)

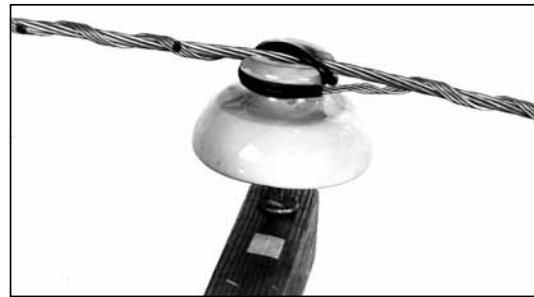
**Figure 30**

The WRAPLOCK Tie should repair excessive tie wire damage that has occurred on armor rodded support points. The WRAPLOCK Tie offers a superior method of securing conductors to insulators because the conductor and insulator are completely surrounded by a resilient elastomer. (Figure 30)

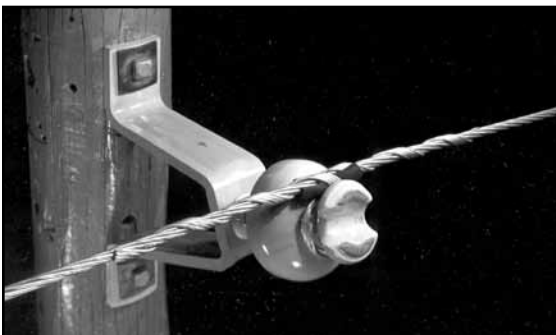
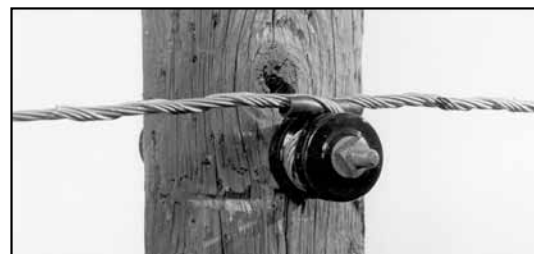
PLP Side Tie and Spool Tie's should replace worn or fatigued ties occurring on spool type insulators or when conductors are "side" mounted on pin or post type insulator. (Figs. 31 and 32 respectively)

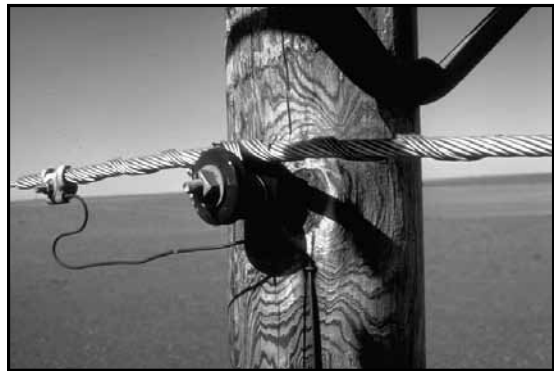
**Severe Weather Tie Kit**

For lines that may experience severe or excessive conditions caused by activity such as aeolian vibration, galloping, heavy ice loads, etc, PLP offers the custom designed Severe Weather Tie Kit. This kit combines the benefits of a factory formed Storm Tie (distribution, spool or double ties) with special length Storm Guards for the best possible tied support. The components of each kit are pre-engineered to provide the correct size Storm Guard and Storm Tie for the conductor and insulator to be used on the line. The Storm Guard component of the kit may also provide conductor repair properties comparable to line guards depending upon the specifics of the conductor damage.

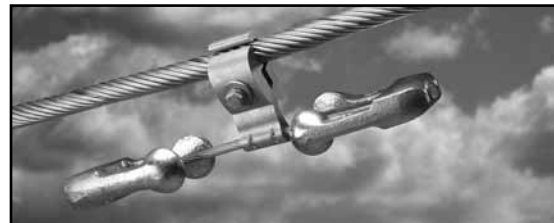
**Figure 35**  
**VORTX Damper**

Contact your PLP representative for specific recommendations for application of VORTX Dampers. (Figure 35)
